Errata
MSP430G2755 Microcontroller

This document describes the known exceptions to the functional specifications (advisories).

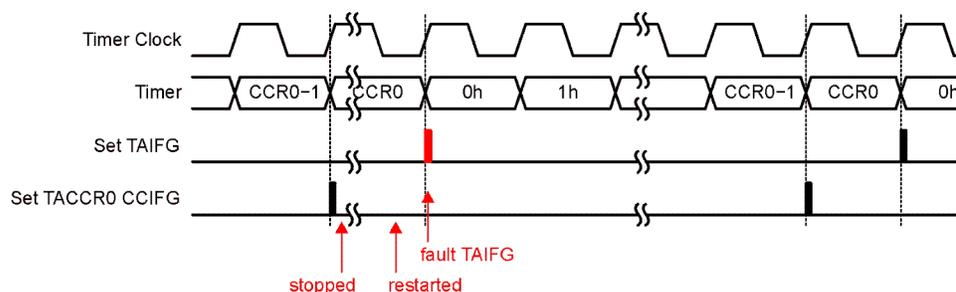
TA21 *TA Module*

Function TAIFG Flag is erroneously set after Timer A restarts in Up Mode

Description In Up Mode, the TAIFG flag should only be set when the timer counts from TACCR0 to zero. However, if the Timer A is stopped at TAR = TACCR0, then cleared (TAR=0) by setting the TACLR bit, and finally restarted in Up Mode, the next rising edge of the TACLK will erroneously set the TAIFG flag.

Workaround None.

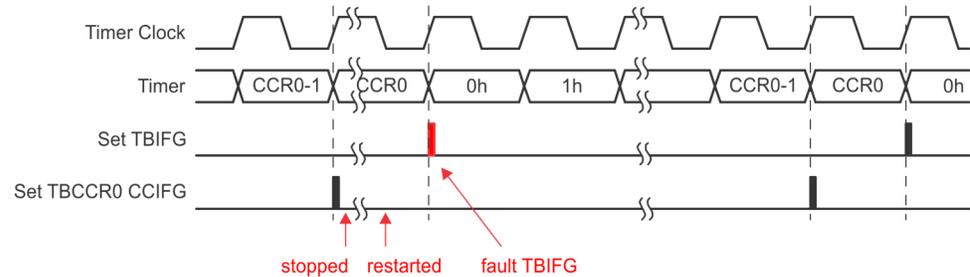
TB24 *TB Module*

Function TBIFG Flag is erroneously set after Timer B restarts in Up Mode

Description In Up Mode, the TBIFG flag should only be set when the timer resets from TBCCR0 to zero. However, if the Timer B is stopped at TBR = TBCCR0, then cleared (TBR=0) by setting the TBCLR bit, and finally restarted in Up Mode, the next rising edge of the TBCLK will erroneously set the TBIFG flag.

Workaround None.
