<b>Device</b>	<b>TC23x</b>
<b>Marking/Step</b>	<b>ES-AC, AC</b>
<b>Package</b>	<b>see Data Sheet</b>

## 10312AERRA

This Errata Sheet describes the deviations from the current user documentation.

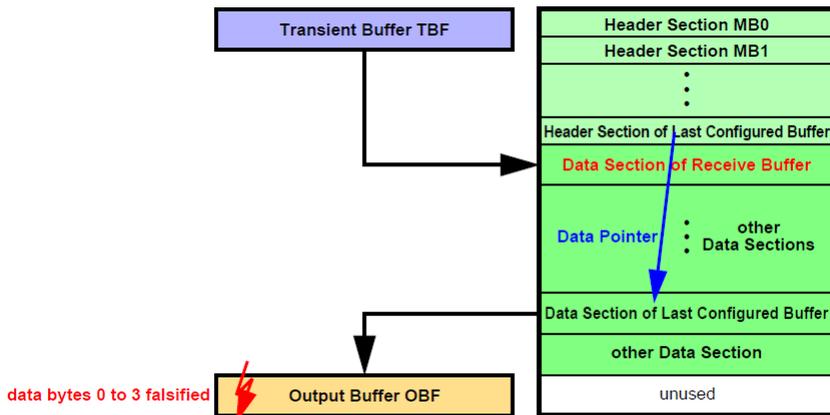
**Figure 1 Message buffer transfer from Message RAM to OBF**

When the message buffer has its payload configured to maximum length (**PLC** = 127), the OBF word on address 00h (payload data bytes 0 to 3) is overwritten with unexpected data at the end of the transfer.

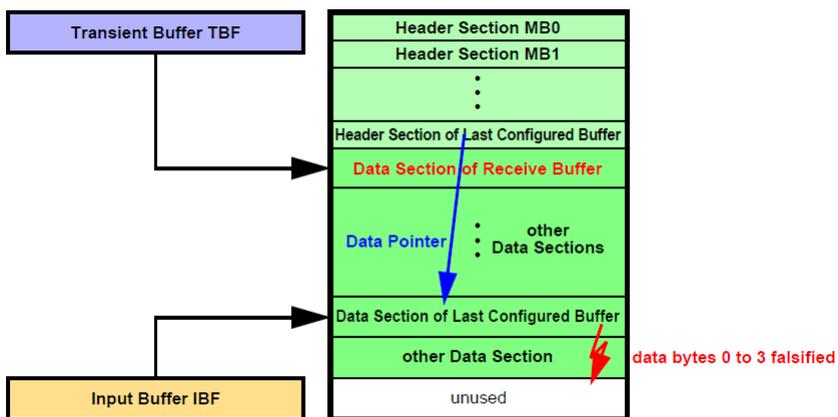
**Figure 2 Message buffer transfer from IBF to Message RAM**

After the Data Section of the selected message buffer in the Message RAM has been written, one additional write access overwrites the following word in the Message RAM which might be the first word of the next Data Section.

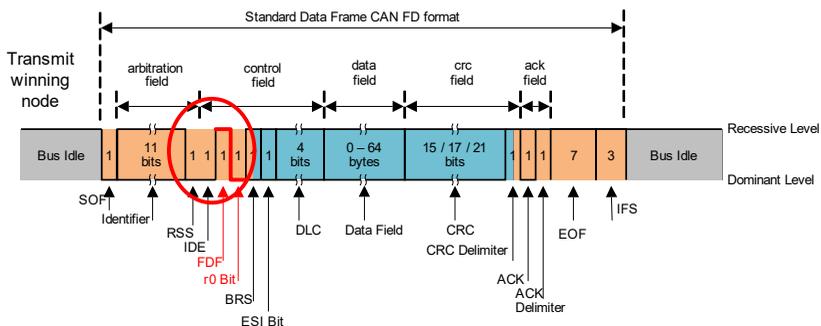
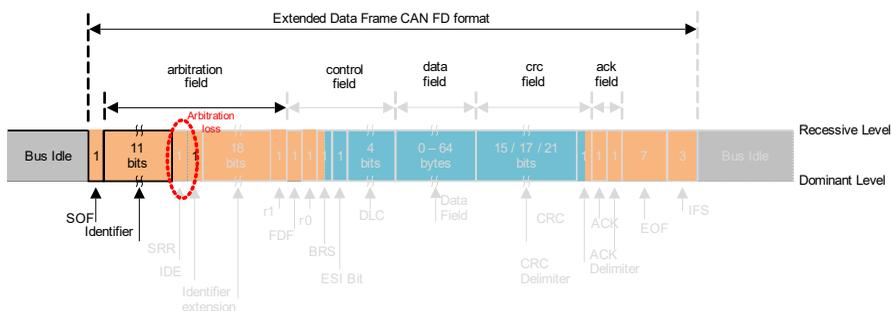
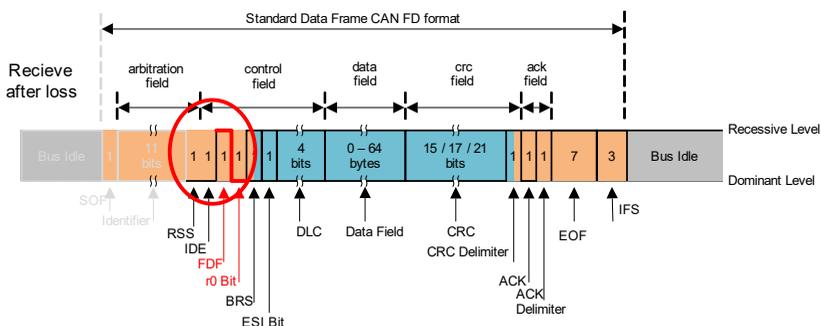
The device is producing more error frames within a network than a device with a hardsync at the FDF bit.

Figure 4 Transmitter - winning CAN FD node

Figure 5 Transmitter - losing CAN FD node

Figure 6 Now receiver (same node as previous figure) - losing CAN FD node

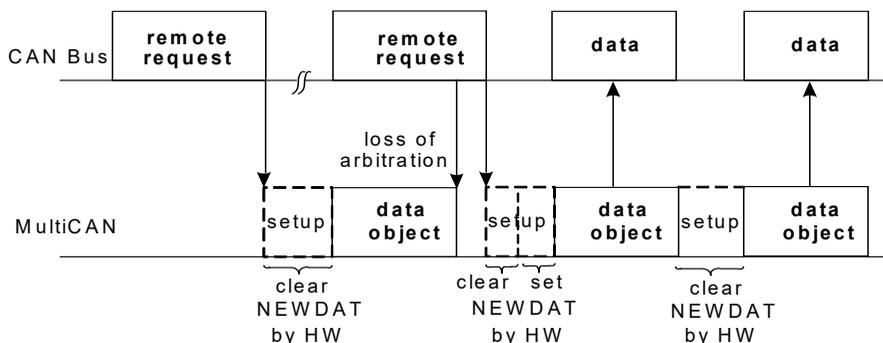
**Figure 9 Loss of Arbitration**

When the appropriate message object (data frame) triggered by the first remote frame wins the arbitration, it will be sent out and NEWDAT is not reset. This leads to an additional data frame, that will be sent by this message object (clearing NEWDAT).

There will, however, not be more data frames than there are corresponding remote requests.

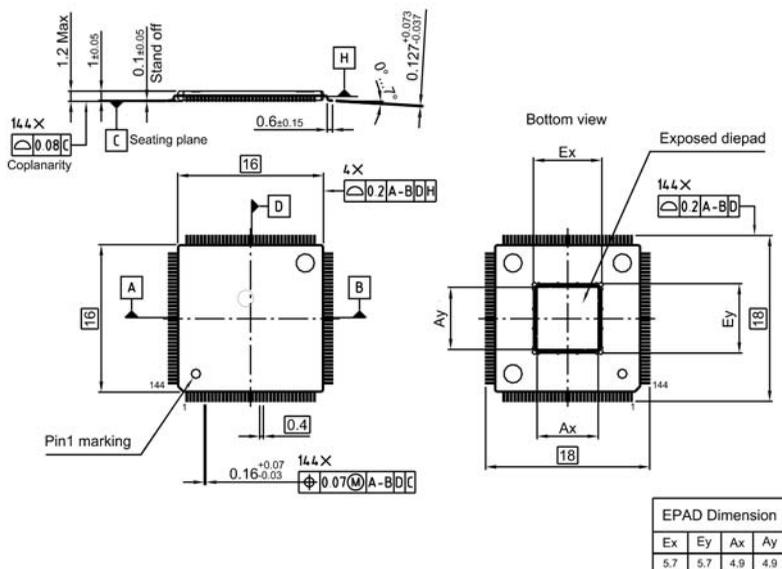
**Figure 12 Package Outlines TQFP-144 for TC23x**

*Note: For the exposed pad of the TQFP-144 package of the TC23x, structural corner protrusions have to be considered for purposes of system design and integration with a maximum boundary of 6.2 mm.*

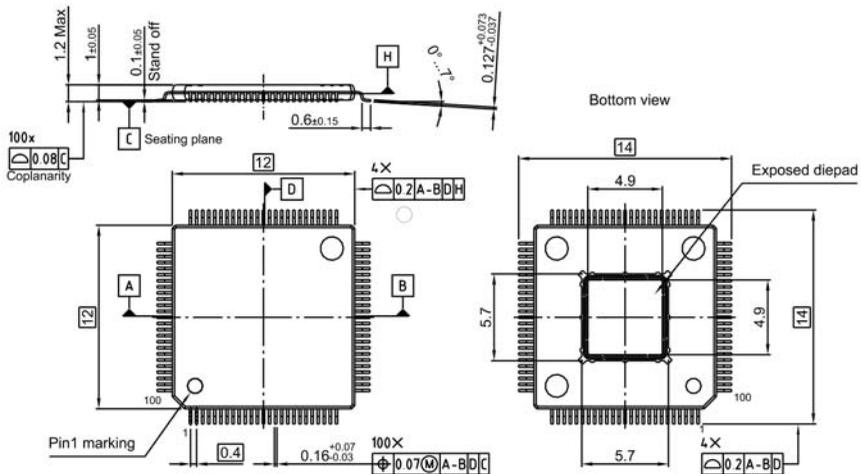
**Figure 13 Package Outlines TQFP-100 for TC23x**

*Note: For the exposed pad of the TQFP-100 package of the TC23x, structural corner protrusions have to be considered for purposes of system design and integration with a maximum boundary of 6.3 mm.*

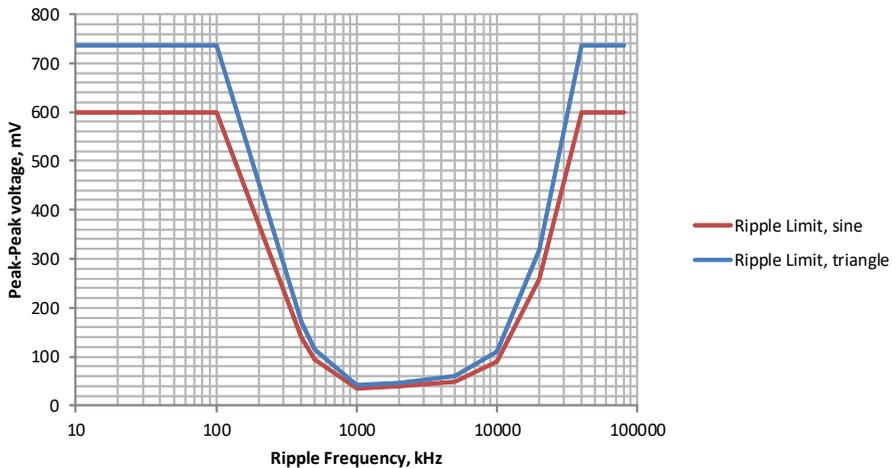
**Figure 14 Ripple Voltage vs. Frequency Characteristic**

The internal back-up clock is sensitive to specific power supply voltage disturbance/ripple caused by a voltage ripple intrinsic to DC-DC converters. Specific conditions such as insufficient filtering of the ripple may lead to improper behavior of the start-up scheme of the back-up clock, and thus stuck-at state during the start-up of the microcontroller until this condition is removed.

The diagram reflects acceptable ripple level during the cold start of the microcontroller at the respective VDDP3/VEXT/VEVRSB supply of the PMS subsystem, depending on the device and package type, as shown in the following table.

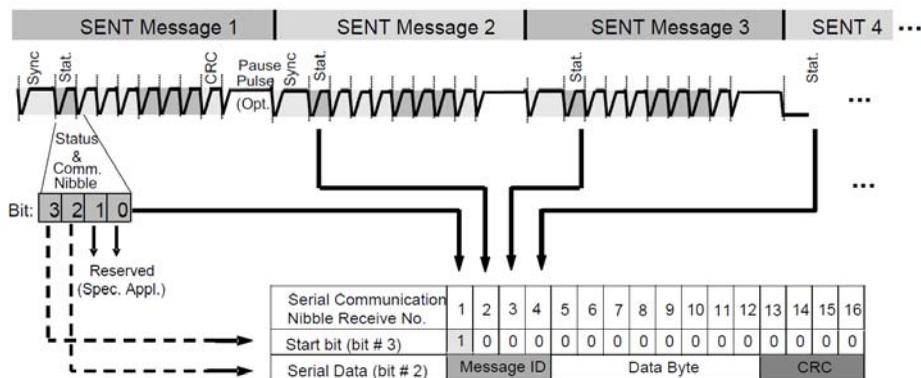
**Figure 15 Short Serial Message, Serial Data Encoding over 16 messages**

**Figure 15** shows a corrected version of this figure.
