ABSTRACT

This document describes the known exceptions to the functional specifications (advisories).

6 Advisory Descriptions

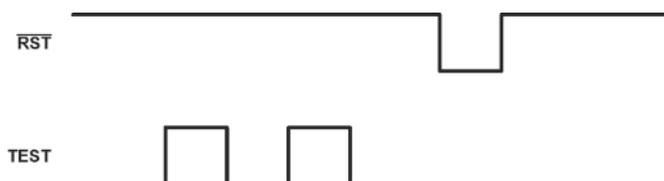
- Toggle the TEST pin twice when nRST is high and after 50us pull nRST low.

Note: This toggling of TEST pins is not subject to timing constraints. The appropriate level transitions on TEST pin, followed by a RST pulse after 50us, are sufficient to trigger an exit from BSL mode.

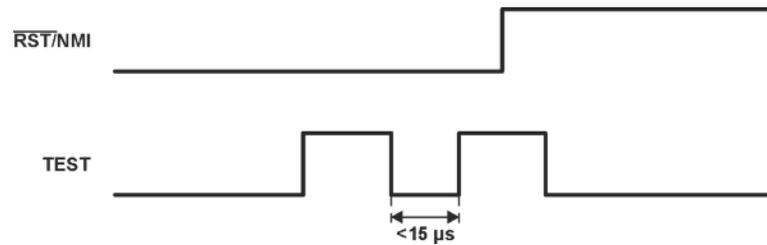
SYS10 *SYS Module*

Category	Functional
Function	BSL entry sequence is subject to specific timing requirements
Description	The BSL entry sequence requires that the low phase of the TEST/SBWTCK pin does not exceed 15us. This timing requirement is faster than most PC serial ports can provide, as shown in the following picture. If this requirement is not met, the entry sequence fails and the SYSBSLIND is not set.

Workaround An external hardware solution is recommended to provide the appropriate BSL entry sequence. See [http://processors.wiki.ti.com/index.php/BSL_\(MSP430\)](http://processors.wiki.ti.com/index.php/BSL_(MSP430)) for recommendations on available BSL hardware.
