Errata
MSP430F5437 Microcontroller

ABSTRACT

This document describes the known exceptions to the functional specifications (advisories).

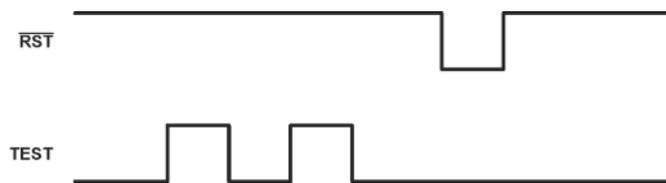
- Toggle the TEST pin twice when nRST is high and after 50us pull nRST low.

Note: This toggling of TEST pins is not subject to timing constraints. The appropriate level transitions on TEST pin, followed by a RST pulse after 50us, are sufficient to trigger an exit from BSL mode.
